**ATLANTIC STATES
WEATHER, INC.**

SAMPLE REPORT

Analysis of Weather Conditions at 323 Smith St, Brooklyn, New York on January 4 - 10, 2018

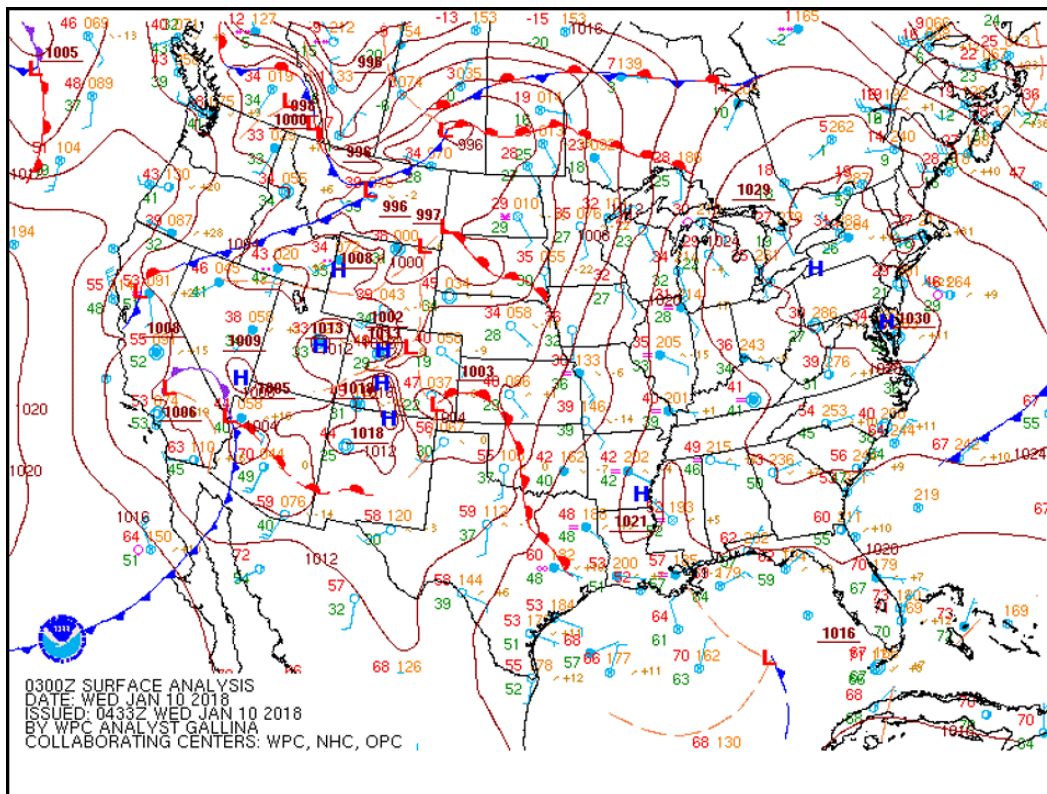
The temperatures noted in the preceding section are valid for the standard observing height of approximately 1.5 – 2 m (5 – 6.5 feet). However, under certain nocturnal atmospheric conditions, to include high pressure, clear skies, and light winds, the actual air temperature immediately above the surface of ground after sunset can be as much as 2-7°F colder than the temperature at the standard observing sensor height. During the evening of January 9-10, 2018, the property was under high pressure conditions, with clear skies and light winds (See Figure 2).

Fig. 2: NWS Surface analysis for 10:00pm EST January 9, 2018. Analysis shows high pressure controlling weather over the northeastern US, including the property.

Given these conditions, it can be conservatively estimated that the air temperature immediately above the surface of the sidewalk at the property was 2°F colder than the observed temperature of 33°F at 11:00 pm and midnight on January 9, 2018. Therefore, the air temperature just above the sidewalk surface was below freezing for at least an hour and half prior to the accident, and possibly for as much as three and half hours (given observed temperature of 35°F at 9:00 pm and 10:00 pm). This would have been more than sufficient time to allow the water on the sidewalk (from melting snow piles during the day) to freeze into a thin, dark sheet of ice on the sidewalk prior to the time of the accident.
